# New Hampshire Volunteer Lake Assessment Program

## 2002 Bi-Annual Report for Beaver Lake Derry

NHDES  
Water Division  
Watershed Management Bureau  
6 Hazen Drive  
Concord, NH 03301

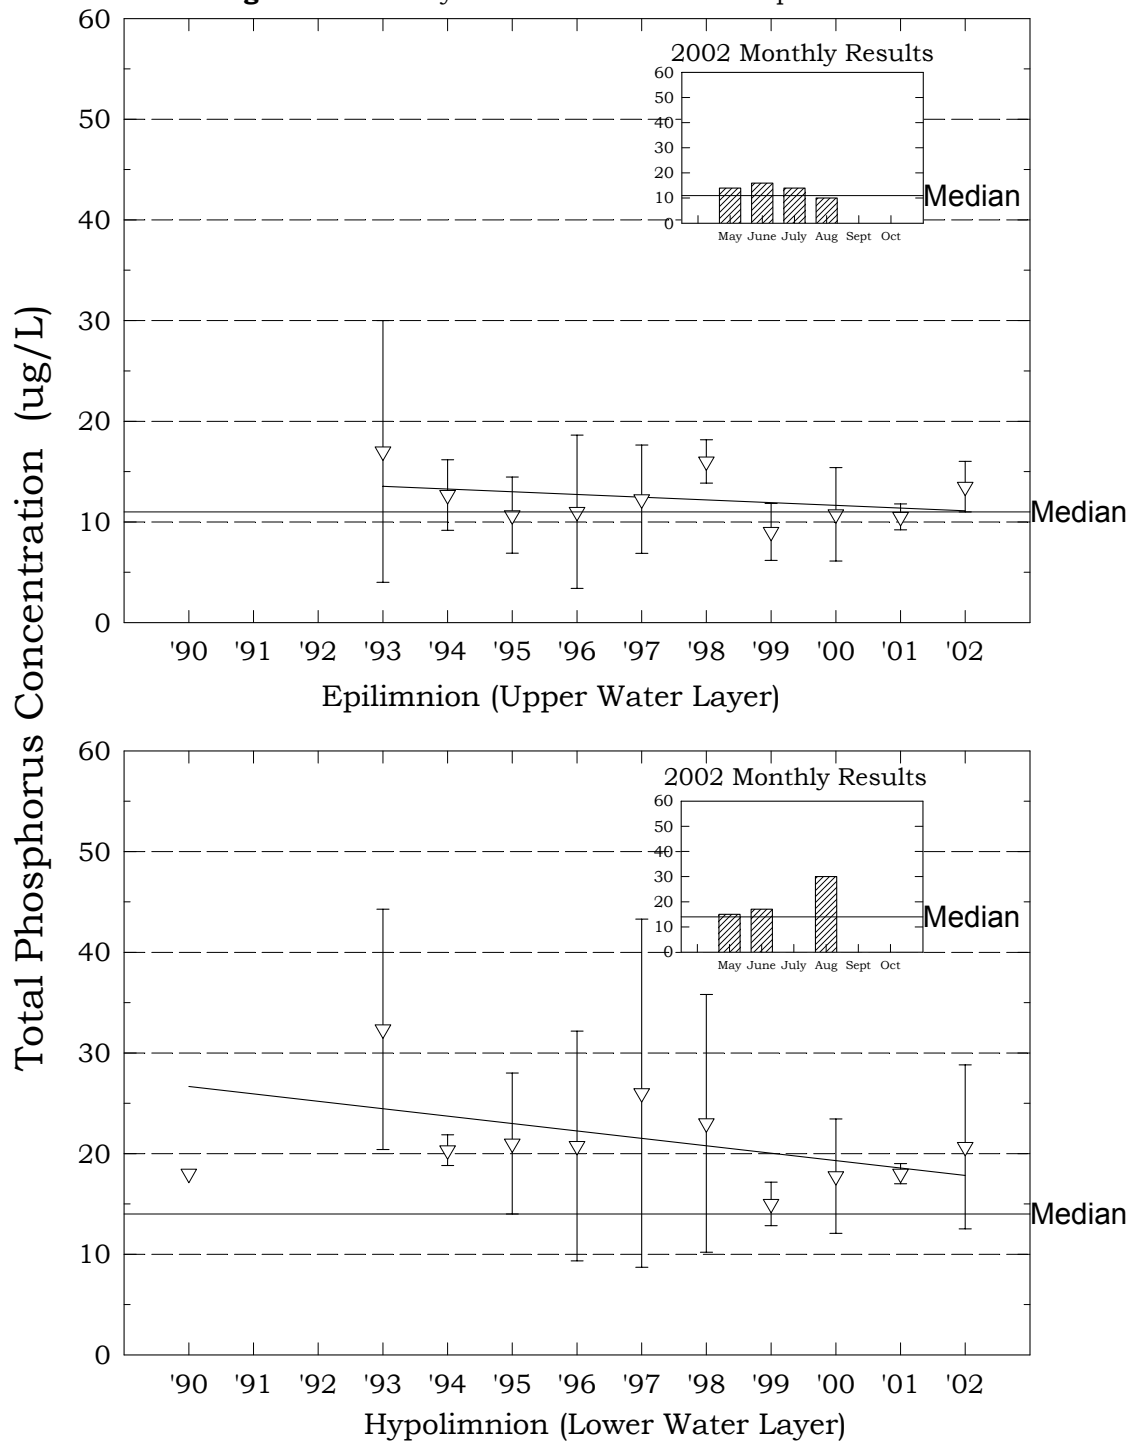
**Figure 3.** Monthly and Historical Total Phosphorus Data.

- **Figure 3 and Table 8:** The graphs in Figure 3 (Appendix A) show the amounts of phosphorus in the epilimnion (the upper layer) and the hypolimnion (the lower layer); the inset graphs show current year data. Table 8 (Appendix B) lists the annual maximum, minimum, and median concentration for each deep spot layer and each tributary since the lake/pond has joined the program.

The current year data for the epilimnion (the top inset graph) show that the total phosphorus concentration **remained relatively stable** from May to August. The total phosphorus concentration on the May, June, and July sampling event was **slightly greater than** the state median, while the concentration on the August sampling event was **slightly less than** the state median.

The historical data show that the 2002 mean epilimnetic total phosphorus concentration was **slightly greater than** the state mean.

The current year data for the hypolimnion (the bottom inset graph) show that the total phosphorus concentration **increased slightly from May** to June, and **increased** by a **large amount** from June to August. Please note that the July total phosphorus concentration was **very high** (72 ug/L) as was the turbidity (7.86 NTUs). This suggests that the lake/pond bottom may have been disturbed by the anchor or by the Kemmerer Bottle while sampling. When the lake/pond bottom is disturbed, sediment, which typically contains attached phosphorus, is released into the water column. When collecting the hypolimnion sample, please check to make sure that there is no sediment in the Kemmerer Bottle before filling the sample bottles. Due to the elevated phosphorus concentration and turbidity, the July phosphorus concentration has been removed.

The historical data show that the 2002 mean hypolimnetic total phosphorus concentration was **greater than** the state mean.

Overall, the statistical analysis of the historical data show that the total phosphorus concentration in the epilimnion (upper layer) has **not significantly changed** (either *increased* or *decreased*) since monitoring began in **1990**. Specifically, the total phosphorus concentration in the epilimnion has remained **relatively stable** and has been **approximately equal to** the state median. (Note: Please refer to Appendix E for the statistical analysis explanation and data print out.)

Overall, the statistical analysis of the historical data (the bottom graph) show that the mean annual total phosphorus concentration in the lower layer has **not significantly changed** (either *increased* or *decreased*) since monitoring began in **1990**. Although the results of the regression test presently show that mean annual phosphorus concentration in the hypolimnion has not **significantly** changed over the years, visual inspection of the trend line shows a **slightly declining** (meaning **improving**) trend. If the mean annual phosphorus concentration in the hypolimnion continues to slightly decrease each season, the decrease may soon become statistically significant. We hope this trend continues! (Note: Please refer to

One of the most important approaches to reducing phosphorus loading to a waterbody is to continually educate watershed residents about its sources and how excessive amounts can adversely impact the ecology and value of lakes and ponds. Phosphorus sources within a lake or pond's watershed typically include septic systems, animal waste, lawn fertilizer, road and construction erosion, and natural wetlands. If you would like to educate watershed residents about how they can help to reduce phosphorus loading into the lake/pond, please contact the VLAP Coordinator.
